**SEATTLE-TACOMA INTL AIRPORT**

**ALERT NOTICE**

**ATTENTION ALL AIRCRAFT LANDING TO THE SOUTH:**

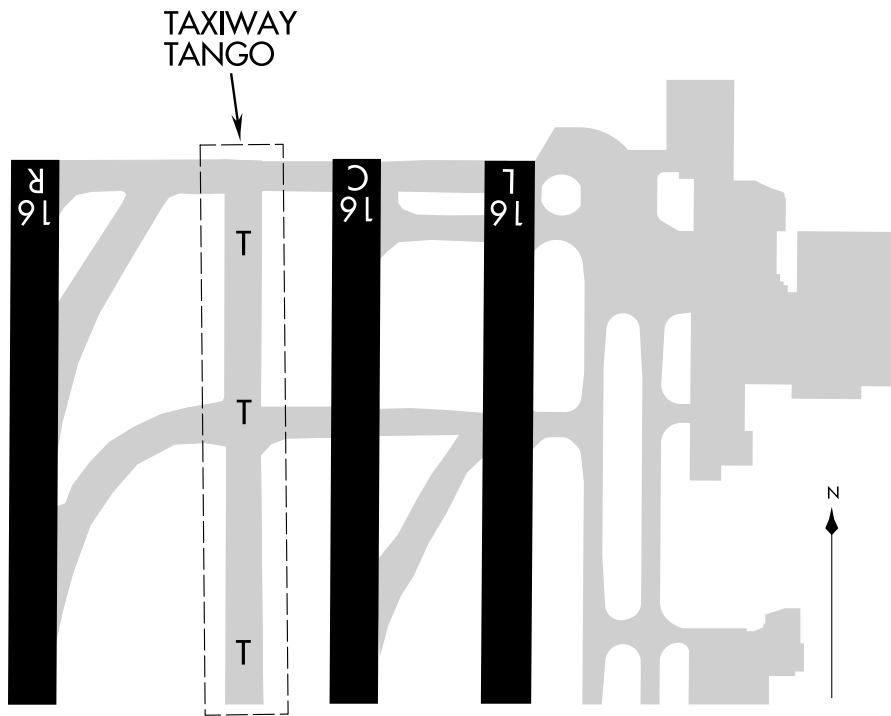
When transitioning from an instrument procedure to a visual approach to Runway 16C, verify you are aligned for the intended landing Runway, not Taxiway Tango. Taxiway Tango is west and parallel to Runway 16C.

Taxiway Tango has been mistaken for Runway 16C from the air during certain visibility conditions, i.e., wet runway, low sun angle reflections. Aircrews are advised to be aware of the proximity of the taxiway to Runway 16C and its runway-like appearance while on approach.

Aircrews should use visual cues, e.g., approach lighting systems, REILs, when available, to confirm alignment with Runway 16C not Taxiway Tango. Additionally, it is recommended when executing a segment of the ILS approach for a visual transition, track the localizer until the runway environment is visually verified.
